# LINCOLN SERVICE BULLETIN

LINCOLN MOTOR COMPANY *Division of* FORD MOTOR COMPANY

Vol. 9

June, 1932

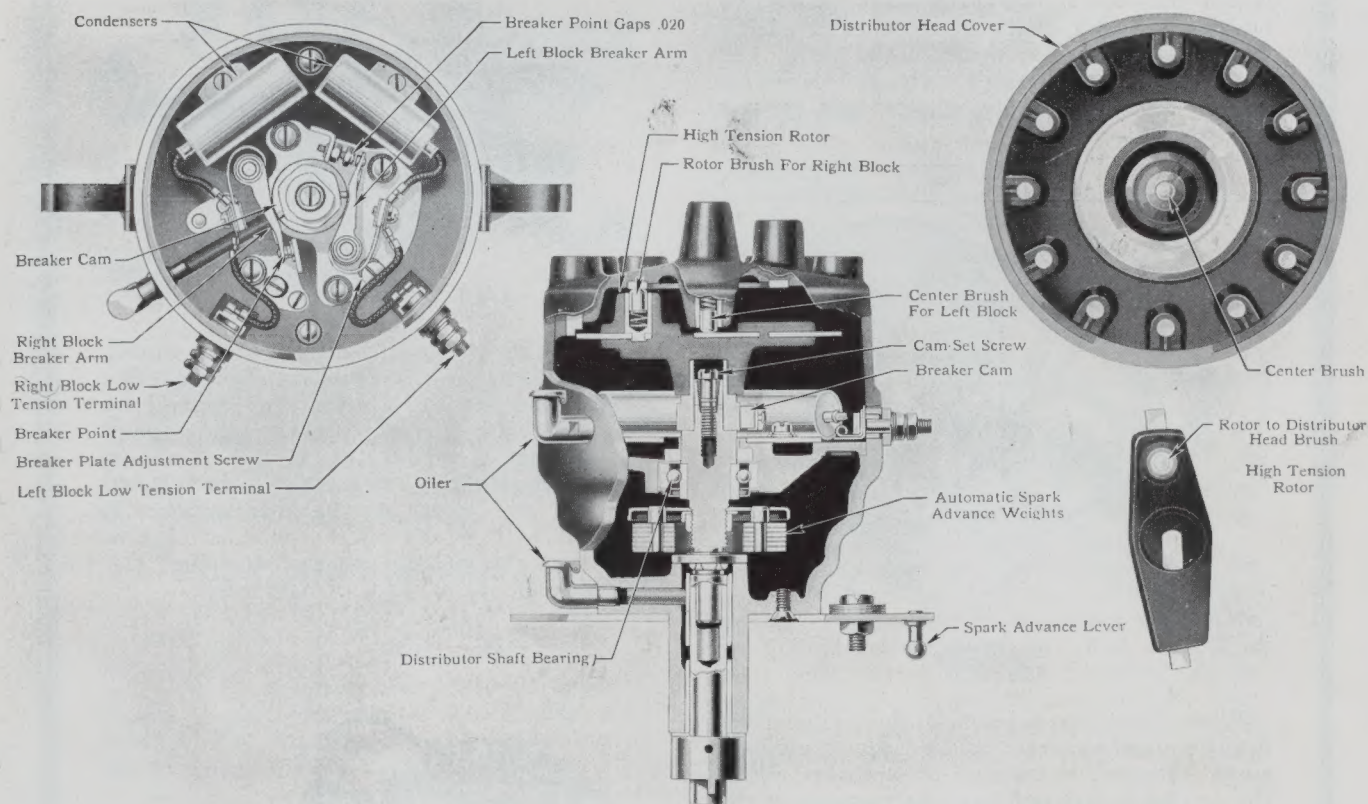
Fig. 123

In general design and construction, the distributor used on V-12 cars closely resembles the V-8 distributor. It consists of the automatic advance governor, located in the lower part of the distributor housing, the breaker mechanism, located on a plate in the upper part of the housing and the secondary distributing mechanism on the top of the unit.

A centrifugal type governor automatically advances the spark to meet all normal driving conditions. The manual spark advance is 20° (on the flywheel) and the automatic advance is 24° giving a total advance of 44°.

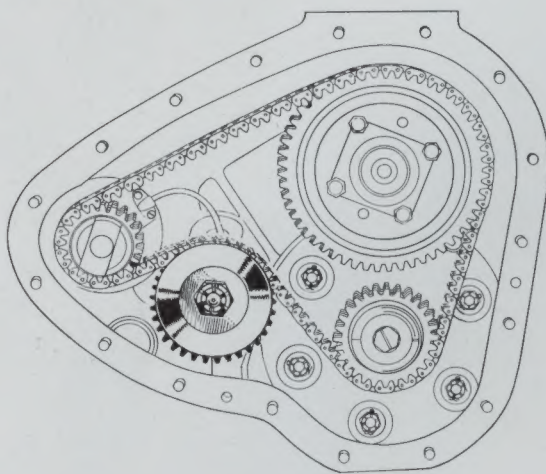
Fig. 124

The tension of the timing chain on V-12 Lincolns is automatically adjusted by a spring actuated mechanism contained in an idler sprocket. See Fig. 124. The idler sprocket support, which is mounted on the crankcase, is rectangular shaped at the outer end. Over this is placed a movable slide which carries the sprocket bushing. Interposed between the support and the sprocket bushing are two springs which maintain a constant pressure against the bushing and thus causes the sprocket to take up any slack which may occur in the chain. The movable slide is provided with ratchets which engage serrations in the support and prevent reverse action.

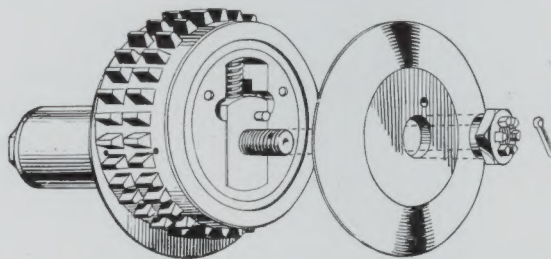
Fig. 125

support to the bushing, and, except when replacing a chain, it should not be necessary to give any attention to this unit. When sufficient wear has taken place that the adjustment has reached its maximum, the chain should be replaced, proceeding as follows after the timing chain cover has been removed.

Remove the cotter pin, nut and thrust washer from the face of the idler sprocket. (See Fig. 125.) The ratchet latches can then be released by inserting two large nails or cotter pins through the openings in the face of the slide as shown in Fig. 126. Holding the latches in the released position, press down on the idler sprocket as far as it will go and insert a wooden plug to hold it in the position illustrated in Fig. 127. The plug should be made of hardwood.

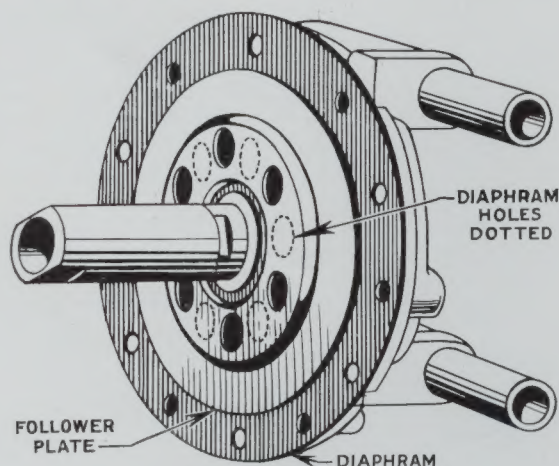
Fig. 128

A few cases have been reported of a whistling noise in the automatic control valve when the brakes are applied. This is caused by the holes in the control valve diaphragm being in line with the holes in the follower plate.

To eliminate this condition, disassemble the control valve and turn the follower plate, Fig. 128, until the holes are staggered from the holes in the diaphragm as indicated in the illustration.

When reinstalling the control valve, it is important that the hoses be properly connected. It will be noted that one connection on the valve is marked "to manifold" and the other "to cylinder." Make sure the correct hose is assembled to each of these connections.

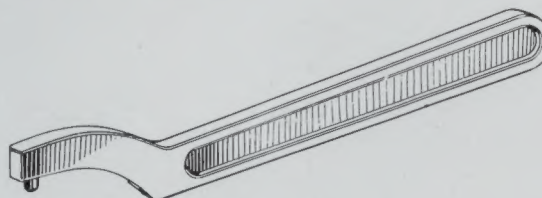
Fig. 129

A wrench similar to the one illustrated in Fig. 99, Page 94, Sept.-Oct. Service Bulletin is now available for removing inside door and regulator handles in present series V-8 cars.

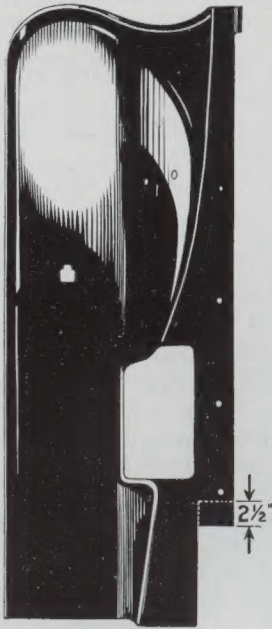
Fig. 130

The front fenders used on V-8 cars are identical with those used on the V-12 with the exception that a small portion of the apron is cut away as shown in Fig. 130. We are therefore, supplying the V-12 fenders in every case where front fenders are ordered for V-8 cars and it will be necessary to cut away the end of the apron before attempting to install the fender. Front fenders for V-8 or V-12 cars should be ordered under the following part numbers:

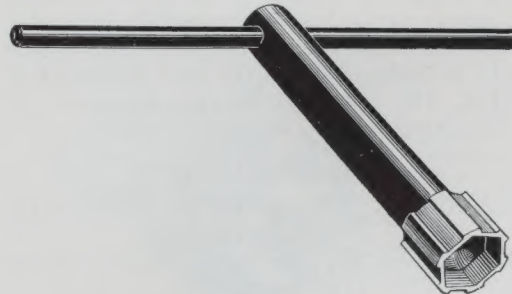
Fig. 131

A special socket wrench for removing the nut which holds the Universal Joint on the spline shaft is illustrated in Fig. 131.
